6160 Wood St, Livonia, MI February 1, 2012

Report No. 2391, v.9

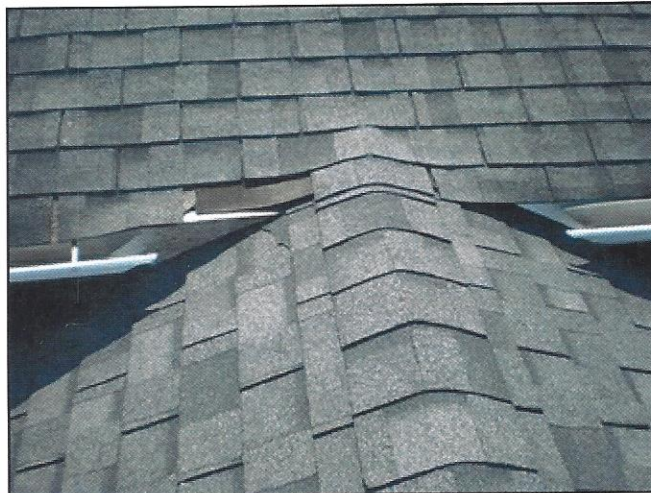
Main roof

1. *Asphalt shingles*
